Journal of Cultural Heritage

Original article

3D damage imaging of Carrara marble sculptures by acoustic tomography coupled to photogrammetry

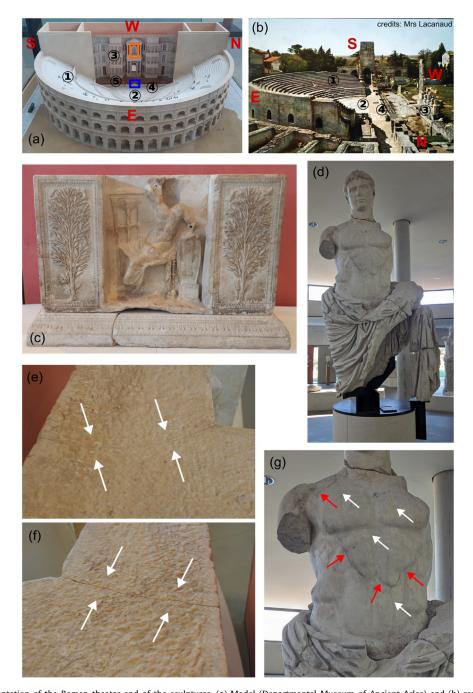
The Apollo altar was discovered during archaeological digs in 1823 and measures about 150 cm in length, 60 cm in width and 95 cm in height [29,31]. On the front side (Fig. 1 (c)), Apollo is represented with a lyre under his left arm and a Delphic tripod behind him. Two jambs are each decorated with a laurel, a tree dedicated to Apollo. The lateral sides of the altar (not displayed here) represent the punishment of Marsyas. The back, which was not visible in Roman times, had not been sculpted and has a smooth surface. At the top surface, two cracks are located at the interfaces between the middle and the lateral parts of the altar (Fig. 1 (e, f)). They go through its entire width and emerge at the front side on a length of about 20 cm. The right-side crack also emerges at the back on a length of 12 cm. The depths of the cracks inside the altar are yet unknown. The curators are particularly worried about the extent of the right-side crack, fearing that this part could break away from the rest of the altar. The artwork is considered very fragile and not moveable, therefore any loan request for exhibition is refused. Thus, a better knowledge on the right-side crack depth would be very helpful for the curators.

Fig. 1. (Color online) Presentation of the Roman theater and of the sculptures. (a) Model (Departmental Museum of Ancient Arles) and (b) remains of the Roman theater of Arles. (1) Cavea, (2) orchestra, (3) scaenae frons, (4) pulpitum, (5) wooden scene. Cardinal directions are indicated in red. The locations of the altar and the statue are indicated by blue and orange boxes, respectively. (c) Apollo altar. (d) Augustus statue. (e) Left-side and (f) right-side cracks on the altar indicated between white arrows. (g) Cracks (indicated by white arrows) and vein (indicated by red arrows) on the statue.

The Augustus statue, displayed in Fig. 1 (d), was originally a sculpture from head to feet. Today, the only remaining parts are Augustus' head (excavated in 1834) and chest (excavated in 1750), both made of Carrara marble, and the drapery (excavated in 1834), made of limestone from the Bois de Lens (Nîmes area, France) [29,31]. The total height of the current statue is of 2.40 m [31]. The Augustus statue exhibits a thick circling vein on the chest and cracks along the vertical direction that seem to be very superficial from visual inspection. The vein and the cracks are indicated in Fig. 1 (g) by red and white arrows, respectively. The statue visually seems less deteriorated than the altar, which could be the first indication of a better conservation of the statue and coincides

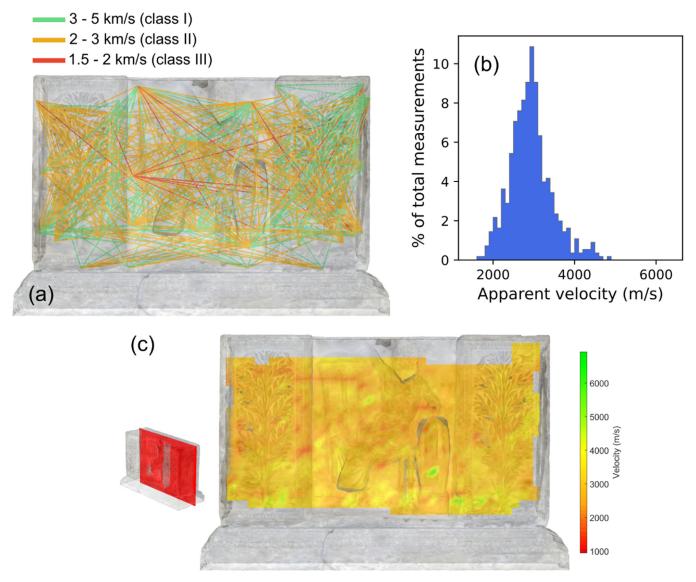
The average apparent and reconstructed velocity values in the Apollo altar are in very good agreement: 2.9 ± 0.5 km/s and 2.9 ± 0.6 km/s, respectively. This average value corresponds to the upper limit of damage class II. Apparent velocities measured in the altar belong to damage class from I (light green lines in Fig. 4 (a)) to III (red lines in Fig. 4 (a)). 3% of total measured apparent propagation velocities belong to damage class III. The analysis of the 3D velocity image slices for the Apollo altar indicates weakest zones at the back of the altar. This is confirmed statistically as 57% of velocities from damage classes III and IV are situated in the last 15 cm of the altar back which represents 41% of the reconstructed volume of the altar.

Fig. 4. (Color online) Tomography results for the Apollo altar. (a) Apparent propagation velocities classified according to Köhler damage classes (Table 1). (b) Histogram of the apparent propagation velocities. (c) Slice in the 3D imaging of the propagation velocity. The slice position is indicated by a red plan.

Regarding weaker areas inside the two sculpted objects, the 3D velocity image of the Apollo altar indicates that the weakest zones of the sculpture are located at its back. This location is not the most exposed to weather conditions. However, the back was against the *pulpitum* wall. Therefore, this zone could have been damper than other altar parts as it was confined against the wall, with also possible capillary rises from the ground. Higher humidity levels could have thus induced more degradation in the altar back.

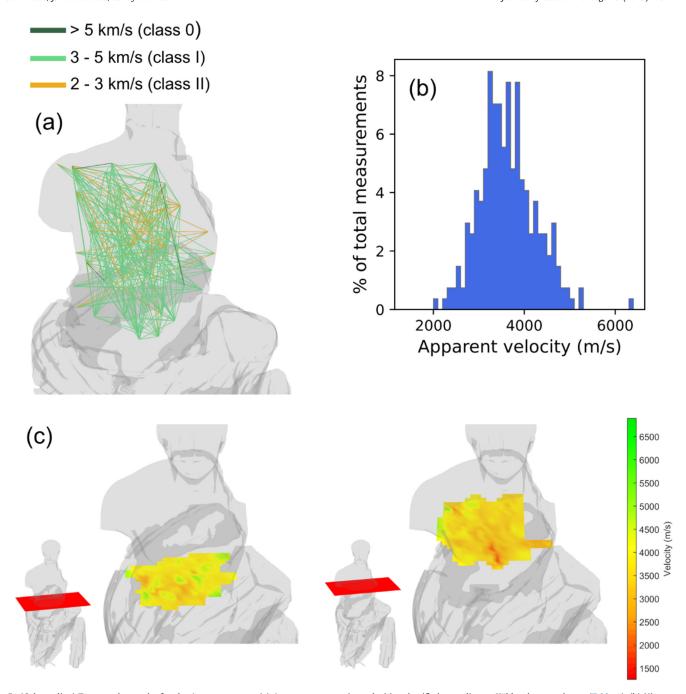
The average apparent and reconstructed velocities are also in agreement in Augustus' chest: 3.6 ± 0.6 km/s and 3.7 ± 0.6 km/s, respectively. Both values correspond to damage class I. The apparent velocities measured in the statue belong to damage class from 0 (dark green lines in Fig. 5 (a)) to II (orange lines in Fig. 5 (a)). The 3D velocity image shows that the upper part of Augustus' chest seems to contain more low velocity values than the lower part (Fig. 5 (b, c)). Velocity counting shows that indeed the upper half of the chest (57% of the reconstructed volume) comprises less class 0 velocities (44%) and more class II velocities (75%) than the lower half. Besides, more velocities from classes II and III (22% of class III velocities in the front quarter of the chest which represents 11% of the reconstructed volume) are found in the front part of the chest.

Fig. 5. (Color online) Tomography results for the Augustus statue. (a) Apparent propagation velocities classified according to Köhler damage classes (Table 1). (b) Histogram of the apparent propagation velocities. (c) Slices in the 3D imaging of the propagation velocity, in the lower and upper parts. The slice positions are indicated by red plans.

The 3D velocity image slices showed that the upper and front parts of Augustus' chest contain more low velocity values than the lower and back parts. Weaker zones in the upper part of the chest could be explained by the presence of a thick vein and of areas of breakage (left arm and head) in this area. Besides, the front part of

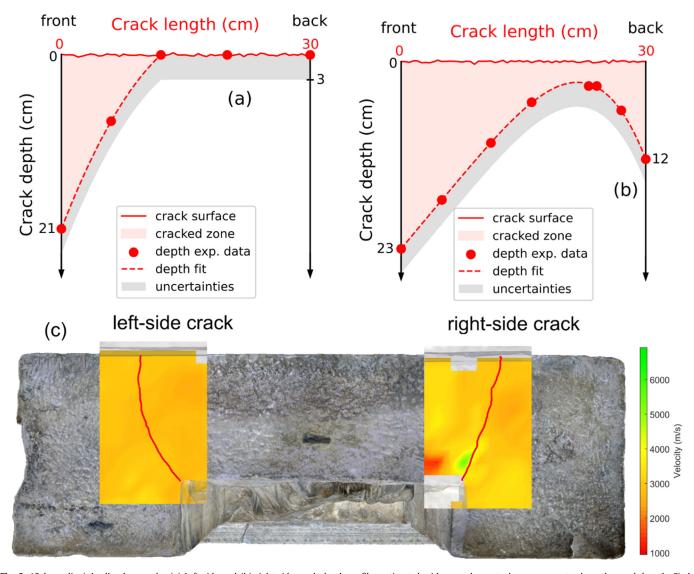
Depth profiles were estimated for the Apollo altar cracks by evaluating their depth at different points along their length. The deduced crack geometries are schematized in Fig. 6 (a, b). The cir-

cle points correspond to the experimental depth measurements. The depth measurement data can be found in the Supplementary Material. The first and last data points were measured directly on the altar surface where the cracks emerge. The first three experimental data of the left-side crack and all the experimental data of the right-side crack were fitted to polynomial laws (dashed line in Fig. 6) to propose an estimation of the general crack depth profiles. The detection limit of the technique is evidenced in grey. The estimated depth profile for the right-side crack has an asymmetrical bell shape with local extrema reached at the altar front and back sides and a shallower portion of the crack in the middle width of the altar. The left-side crack is very superficial (probably shallower than 3 cm), except at the very front of the altar. The relationship between the time of flight and the distance was always linear for this crack, except at the first measurement point.

is the nearest reconstructed cartography to the altar top. The crack profiles at the surface are indicated by the red solid lines. This cartography can be compared to the crack depth estimations. According to the estimated depth profiles, at 12 cm from the top surface both cracks should be present at the front of the altar. However, the front part of the right-side crack coincides with a high velocity zone on the velocity cartography and the velocity in the zone of the left-side crack is very uniform.

Fig. 6. (Color online) Apollo altar cracks. (a) Left side and (b) right side crack depth profiles estimated with several punctual measurements along the crack length. Circle data points correspond to experimental depth measurements, the dashed lines to polynomial fits of the experimental depths, the red zones to the cracked zones, the grey zones to uncertainties. (c) Velocity cartography in the crack zones of the Apollo altar at 12 cm below the top surface. The crack profiles at the surface are indicated by red solid lines.

structed local propagation velocities (Fig. 6). This lack of correlation may be due to the acquisition, reconstruction or interpolation procedures that tend to average the velocity values and could erase the effects of very local defects, or it could indicate that the cracks do not significantly impact the mechanical integrity of the altar.

The right-side crack was the most worrying for the curators. They feared that this crack had propagated across the entire height of the altar and that the right part would break away from the rest of the altar if it were moved. The estimated profiles (Fig. 6 (a, b)) for both cracks highlight that the right-side crack is indeed the most worrying one. However, they also show that this crack has not yet spread across the entire altar height. Therefore, the altar parts on either side of the crack still hold together. Nevertheless, moving the altar could increase the crack propagation and result in fracture. Therefore, the altar should not be moved without conservation operations. In the meantime, the risk associated with such displacements could be evaluated by conducting numerical simulations of the crack mechanical behavior in different displacement situations.
