Journal of Cultural Heritage

Original article

3D damage imaging of Carrara marble sculptures by acoustic tomography coupled to photogrammetry

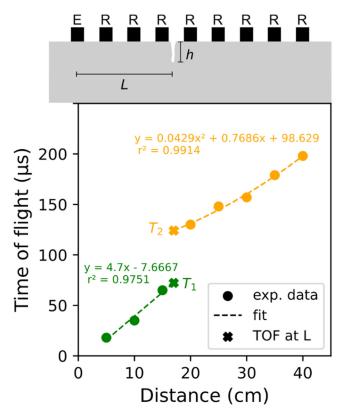
Fig. 3. (Color online) Explanatory scheme of the time-of-flight diffraction (TOFD) method. E denotes the emitter position and R the receiver positions. The crack depth h is estimated from the times of flight T_1 and T_2 obtained at the crack position L (here, L = 17 cm) from the linear and polynomial fits, respectively before and after the crack. Here, a depth h of 10 cm may be deduced.
