16th Quantitative Infrared Thermography Conference

Active thermography for panel paintings inspection: A comparative study of mid-wave and long-wave Infrared spectral analysis.

by S. Boubanga Tombet*, E. Guyot*, R. Huillery**, T. Calligaro***, V. Detalle***, X. Bai***, and A. Semerok****

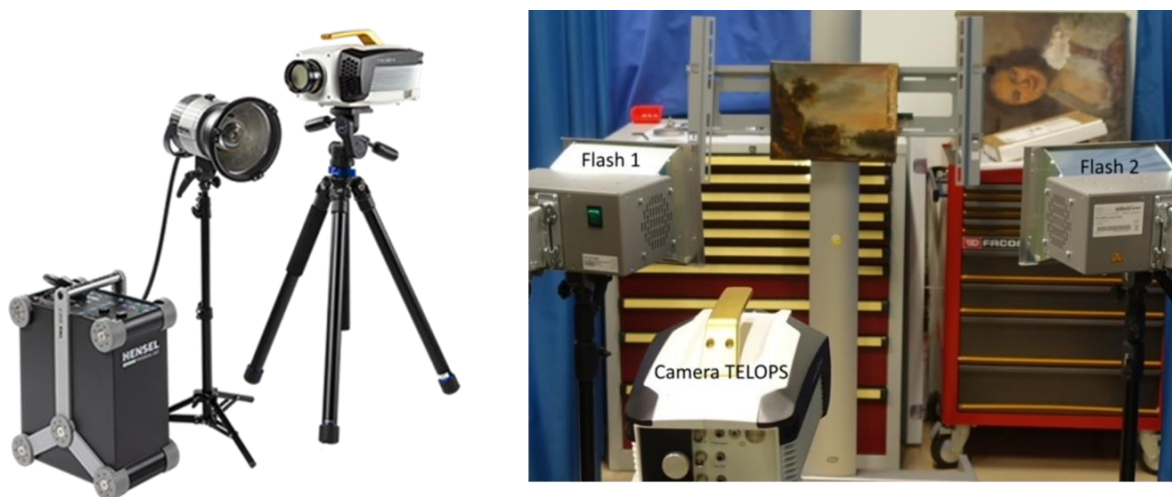
Figure 1. Active thermography set up and experimental configuration including the paintings, TELOPS camera and two flash lamps.

In our studies, an active pulsed thermography system (PTvis setup of EDEVIS GmbH, provided by Thermoconcept) for the specimen analysis was used (**Figure 1**). This system offers non-destructive testing solutions for the evaluation of components or assemblies and subsurface defect detection without damaging the materials. The active thermography solution combines mid- and long-wavelength infrared TELOPS cameras (MWIR or LWIR), different external excitation sources solutions and user-friendly post-processing software. External excitation sources such as flash and halogen lamps or lasers are available along with electromagnetic and mechanical sources (inductive coils, ultrasound generators). A wide range of solutions is available from basic systems to compact integrated systems with a variable level of automatization depending on the measurement needs and constraints.

An active thermography setup (**Figure 1**) was used for characterisation of multi-layered structures of panel paintings and analysis of defects caused by aging and environmental effects. Two oil compositions painted on canvas (**Figures 2a-b**) were provided by Centre de Recherche et de Restauration des Musées de France (C2RMF) in the Louvre museum. Pulsed Thermography PTvis setup (EDEVIS GmbH) was applied to provide and inspect a dynamic thermal response, which was recorded by mid- and long wavelength infrared TELOPS cameras. Control, synchronization and data analyses were provided by EDEVIS DisplayImaging Professional software provided by Thermoconcept.

Active Pulsed Thermography (PT) was used for two-spectral band (LWIR and MWIR) inspection of the painting specimen. PT method may be seen as one of the earliest one among those of active thermography [7]. The method is often referred to as “flash thermography” since in its classical configuration, a set of industrial flashes is used to heat the surface of the inspected object. Pulsed Phase Thermography (PPT) [8] was used as an advanced processing technique to analyse the acquired data. In our studies, two flash-pulse excitation sources were used. The maximum output power of each excitation source was 3 kJ, and a flash-pulse duration was about 3 ms. Thermal response of each specimen was measured by high-speed, high-sensitive cooled IR cameras (TELOPS), such as MWIR (FAST M350, 1.5-5 μm) and LWIR (FAST L200, 7.5-11.5 μm), having 640 \times 512 pixels resolution and \sim 20 mk of Noise Equivalent Temperature Difference (NETD) at 25 °C. An optical lens (50 mm focal length) and the camera/sample distance in the range of 0.8 - 3 m allowed one to obtain the spatial resolution between 200 and 900 $\mu\text{m}/\text{pixel}$. The camera frame rate was 100 Hz, and the IR acquisition duration was about 30 s.

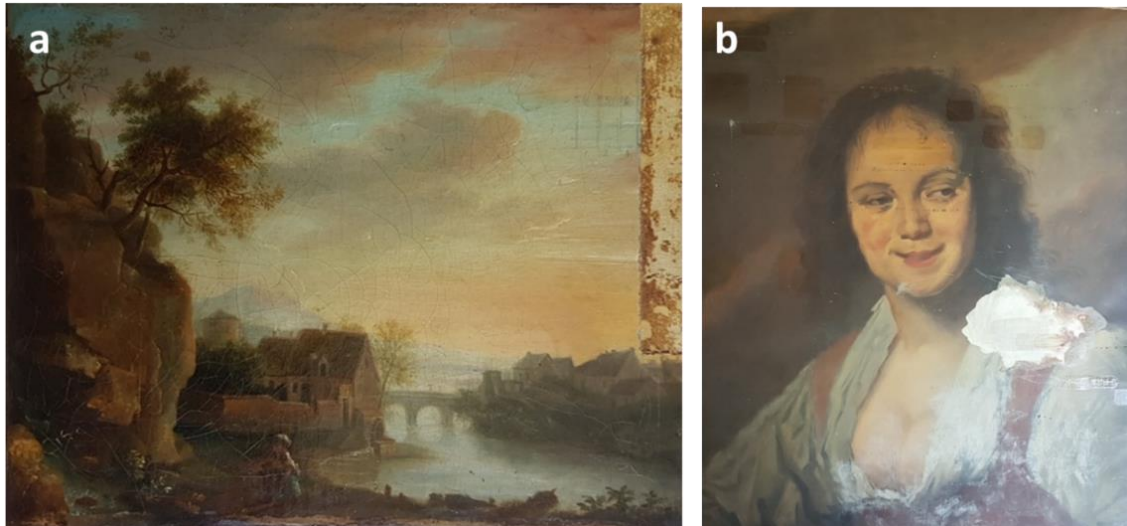
Figure 2. Photographs of the paintings analysed by active pulsed thermography, (a) - XIX century painting (26 cm x 32 cm), XIX century, (b) - replica of Frans Hals *La Bohémienne* (46 cm x 55 cm).

In this work, two panel paintings provided by C2RMF were analysed (**Figures 2a and 2b**). The painting in **Figure 2.a** is about 26 cm \times 32 cm, the XIX century. The top right zone of the painting was peeled off for the previous analysis (not discussed in this paper). The painting in **Figure 2.b** is about 46 cm \times 55 cm and represents a replica (46 cm \times 55 cm) of Frans Hals, “*La Bohémienne*”, (1628-1630). Some zones on this painting were also intentionally peeled off for the previous analysis (not discussed in this paper).

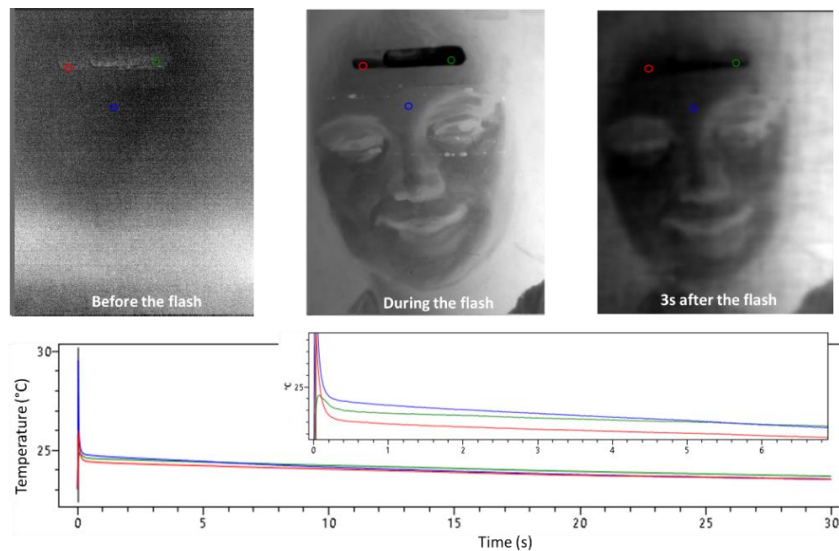
Figure 3. Temperature map of the replica “*La Bohémienne*” recorded before, during and after the flash lamp excitation (upper panels) at 1m distance between the camera and the painting, and Transient temperature curve of the three zones of different thickness (indicated by red, blue, green circles) with a zoom from 0 to 7 sec (lower panel).

The replica of Frans Hals “*La Bohémienne*” painting (see **Figure 2b**) was under Pulsed Thermography experiments performed in reflection mode. The panel painting sample with the three zones with different painting thickness (indicated as red, green, and blue circles in **Figure 3**) was submitted to the thermal pulse generated by the flash lamp, which resulted in non-stationary heat flow in the sample. Then, during the cooling process, the thermal infrared radiation emitted by the replica “*La Bohémienne*” painting was recorded by the IR camera as a function of time. The distance between the camera and the panel painting was one meter in this case. Both the flash excitation and the temperature profiles of the three zones of different painting thickness were measured before, during and after the flash lamp excitation (**Figure 3**, the lower panel). Continuous non-periodical signal decays can be seen after the temperature increase generated by the flash. The cooling dynamics in the three zones was different, which shows the different heat propagation properties in the zones with different thermomechanical properties and thickness.

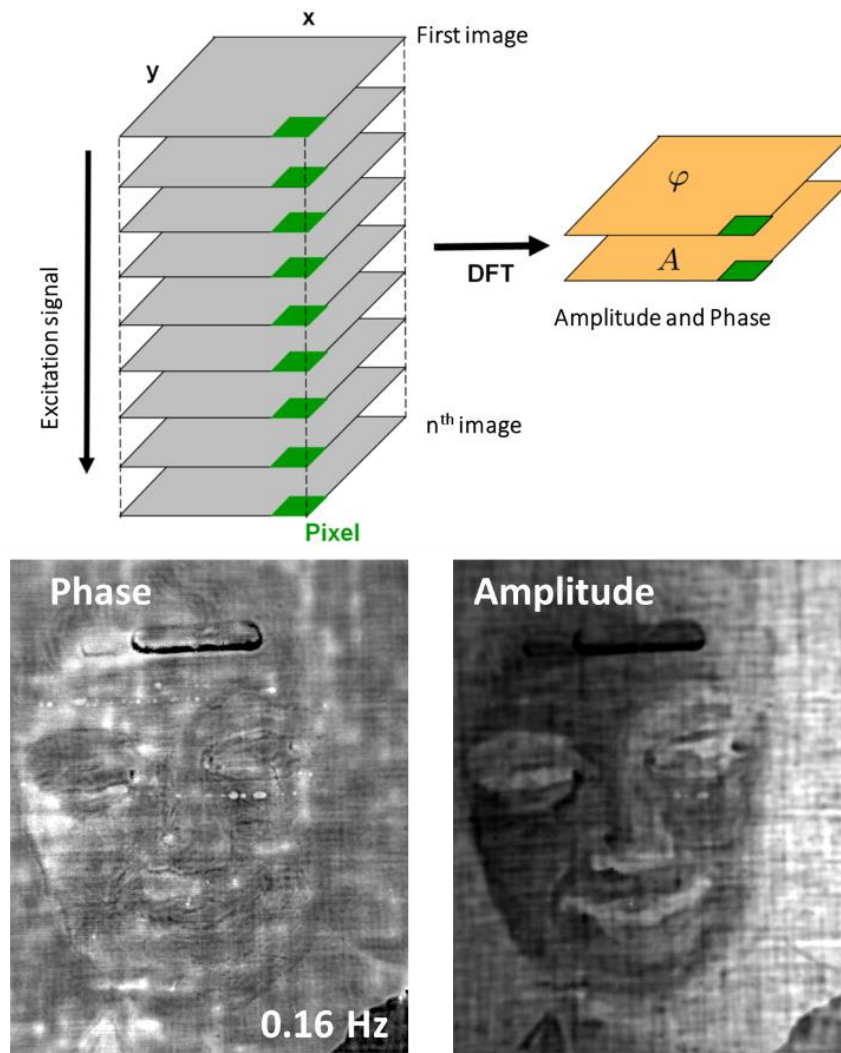
Figure 4. Workflow of the Pulse-phase-thermography used by DisplayImg Professional software. The example of phase and amplitude images computed by the software for $\nu = 0.16$ Hz for a distance between the painting and the camera of one meter.

The data analysis of pulsed thermography obtained with the replica “*La Bohémienne*” was made with the EDEVIS DisplayImg Professional software (provided by Thermoconcept). This software provides an optimum workflow, while offering a wide range of powerful functions to analyse and post-process images and image sequences. The Discrete Fourier transform (DFT) was used to compute the amplitude and the phase images. **Figure 4** (lower panel) presents the example of phase and amplitude data obtained from the measurements of the replica “*La Bohémienne*”. For pulsed thermography analysis, the phase data are of particular interest because they are less affected by environmental reflections, emissivity variations, non-uniform heating, surface geometry and orientation if compared to raw thermal data. This consideration is of particular importance for a quantitative analysis. From **Figure 4**, one can see that the phase image reveals more details (for example, possible pencil drawings underneath) as compared to the amplitude image.

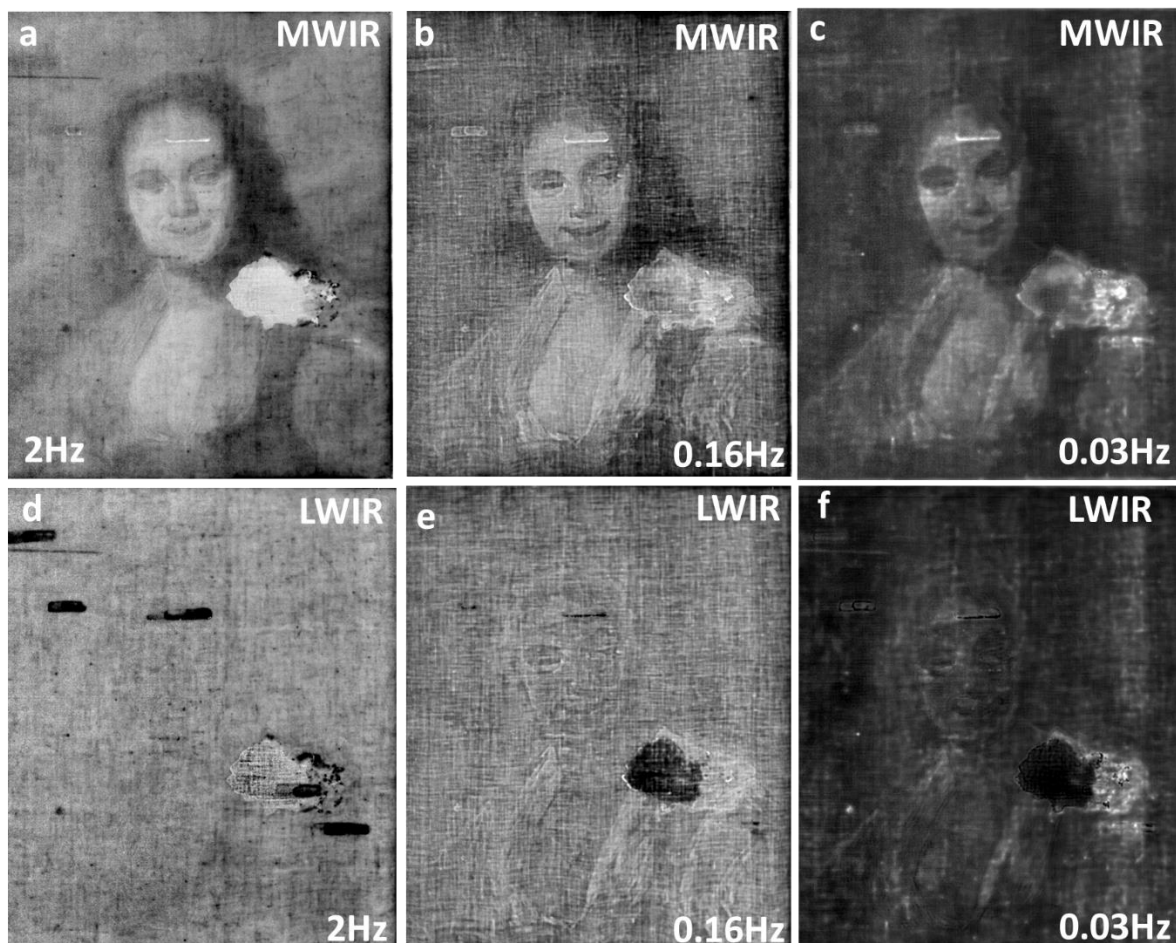
Figure 5. Phase images of the Franz Hals replica obtained with a MWIR camera (a, b, c) and LWIR camera (d, e, f) for different ν (Hz) at a distance camera-painting of 3 m .

Phase images were of a particular interest since most of the detrimental thermal and optical effects observed in pulse phase thermography could be considerably reduced. **Figures 5.a-f** (for the replica “*La Bohémienne*” painting) and **Figures 6.a-f** (for the XIX century painting) present the Fourier transformation and phase analysis results that were obtained with a MWIR camera (**Figures 5.a-c** and **Figures 6.a-c**) and LWIR camera (**Figures 5.d-f** and **Figures 6.d-f**) at a distance camera-painting of 3 m and 1.7 m respectively. In pulse phase thermography, the deeper layers are seen at low frequencies, while shallow ones are seen at high frequencies.

For the replica painting, **Figure 5b** (MWIR) and **Figure 5e** (LWIR) clearly show the textile support of the canvas. The canvas fibres are observed with the same resolution in both infrared bands, thus demonstrating the potentiality of pulsed infrared thermography to penetrate the paintings from the front side down to a decent depth for *in situ* measurements. It should be noted that the replica “*La Bohémienne*” was more clearly seen on MWIR phase images at all frequencies than that on LWIR ones. The paint layers were intentionally removed in a limited zone to analyse the preparation layer. In this layer, phase images of a stronger contrast were obtained in LWIR than in MWIR. Identical defects were also seen at 2 Hz both in MWIR and LWIR, but the contrast was higher in LWIR. For the XIX century painting, pulse phase thermography imaging also allowed us to identify the canvas in two infrared bands (MWIR and LWIR in **Figure 6b** and **Figure 6e**, respectively). Numerous random dark spots (**Figure 6c** and **Figure 6f**) may be interpreted as a possible presence of glue droplets used to attach the old canvas on the new one. Indeed, previous investigations have shown that the original painting underwent a transposition in early XX century, which is a common practice in restoration process. And this painting is contested undergo this process. The pulse phase thermography imaging of this painting has revealed that the painting pigments are seen more clearly in MWIR phase images (see **Figure 6a** with a tree painted at the top left). In contrast, the painting pigments in LWIR phase images are practically not visible (see **Figure 6d**, for comparison). Our analysis revealed the presence of a pentimento (**Figures 6.d-e**, on the lower right part with a church steeple shape). The pentimento appears to be less detectable in MWIR images. Other features, such as, underdrawings and pencil marks were also detected during the analysis of the XIX century painting.

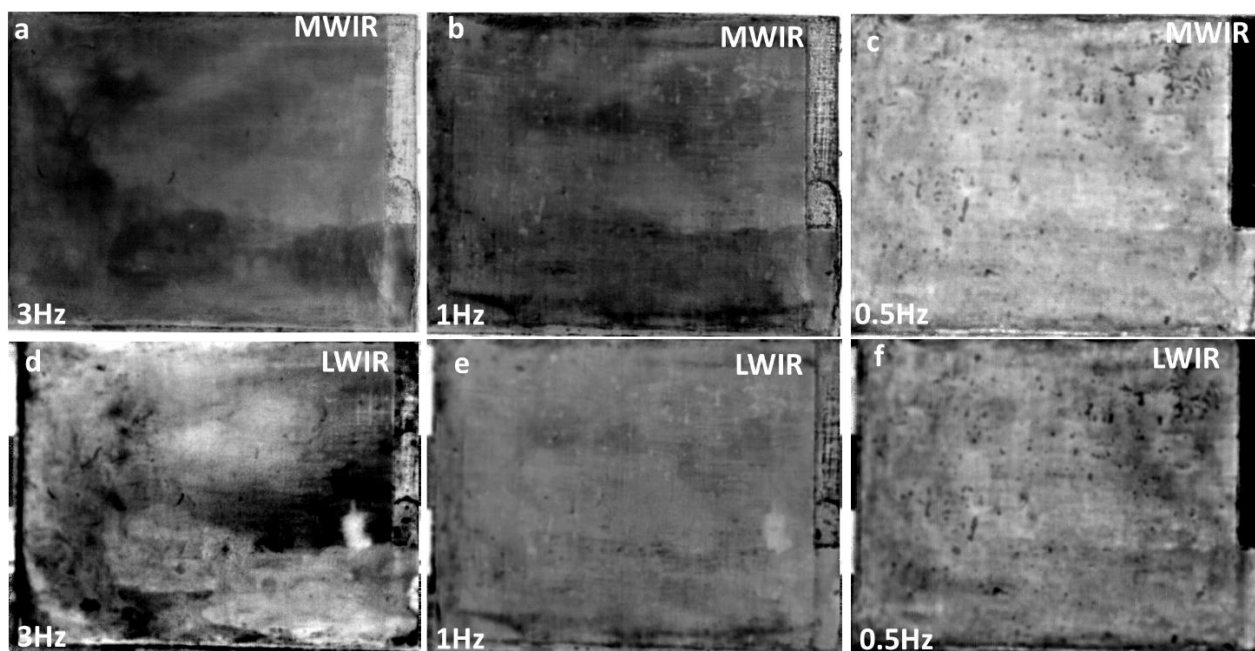
Figure 6. Phase images of the XIX century painting obtained with a MWIR camera (a, b, c) and LWIR camera (d, e, f) for different ν (Hz) at a distance camera-painting of 1.7 m.
